Arizona State Route 260

Preacher Canyon Wildlife Fence and Crosswalk Enhancement Project Evaluation

Final Report - Project JPA 04-088

February 2010

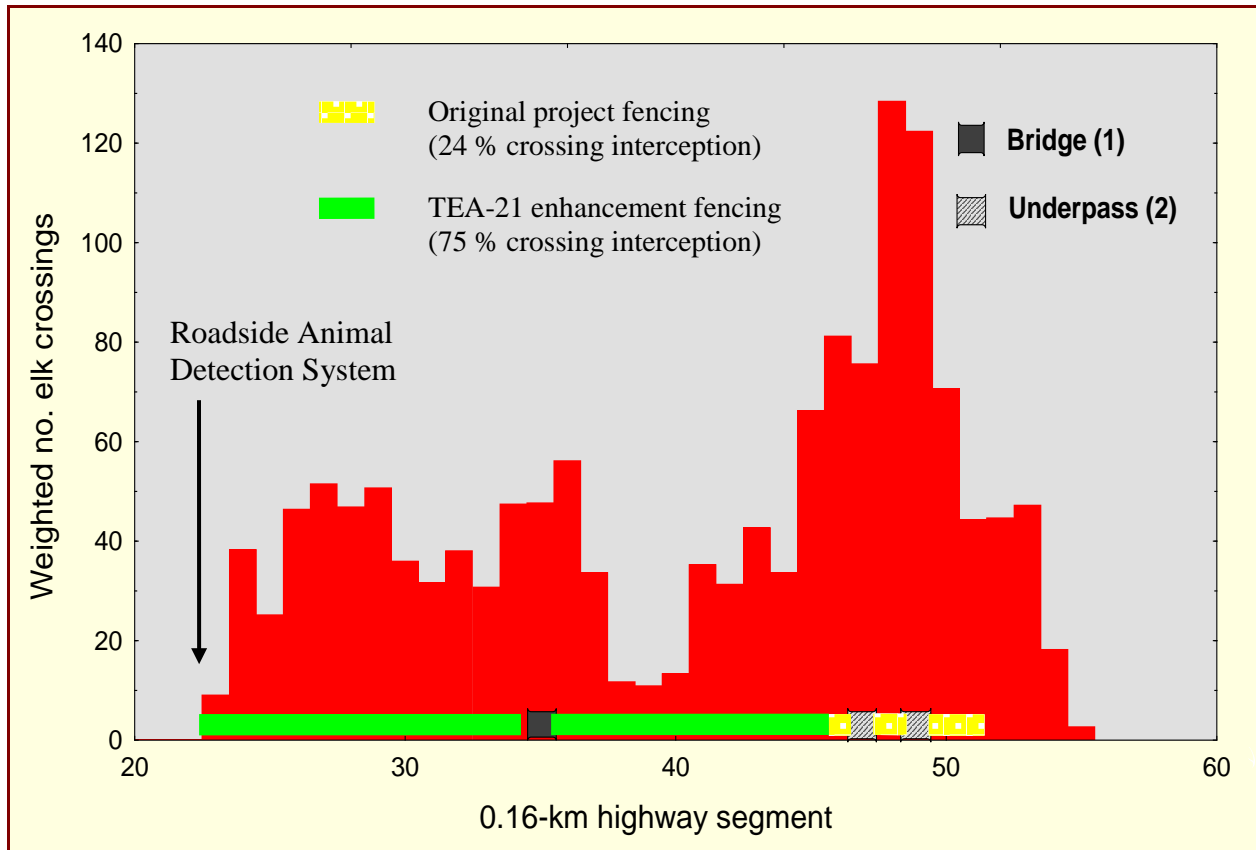
Figure 2.1. Distribution of SR 260 crossings by GPS-collared elk along the Preacher Canyon section from 2002 to 2004 in relation to the location of the original extent of ungulate-proof fencing (yellow) erected during highway reconstruction and location of additional proposed enhancement fencing (green) to intercept and funnel elk to the Preacher Canyon Bridge, Little Green Valley underpasses, and RADS.

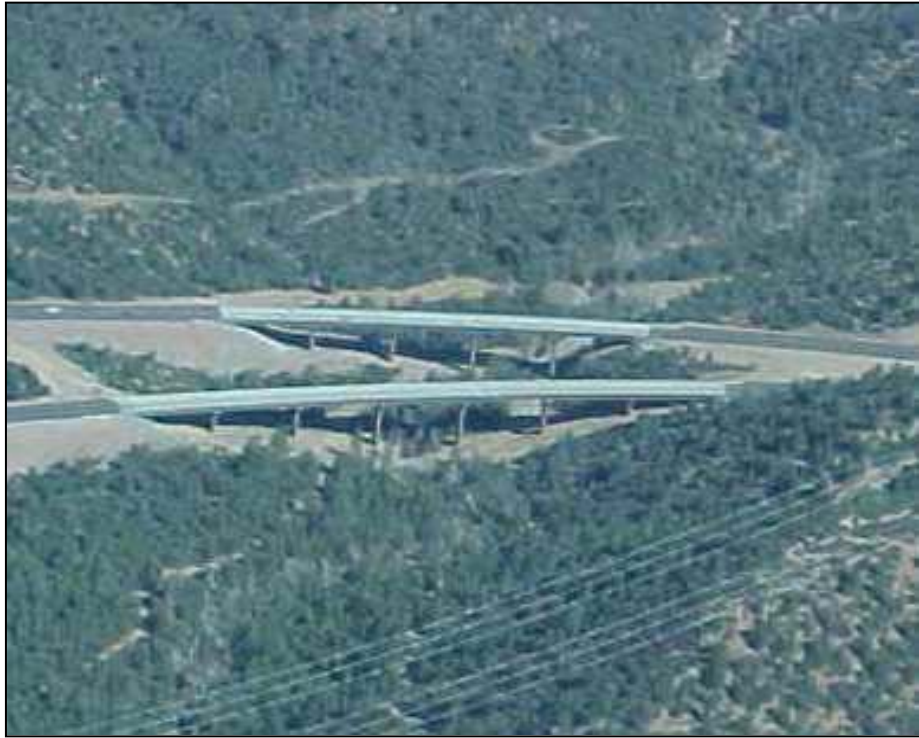
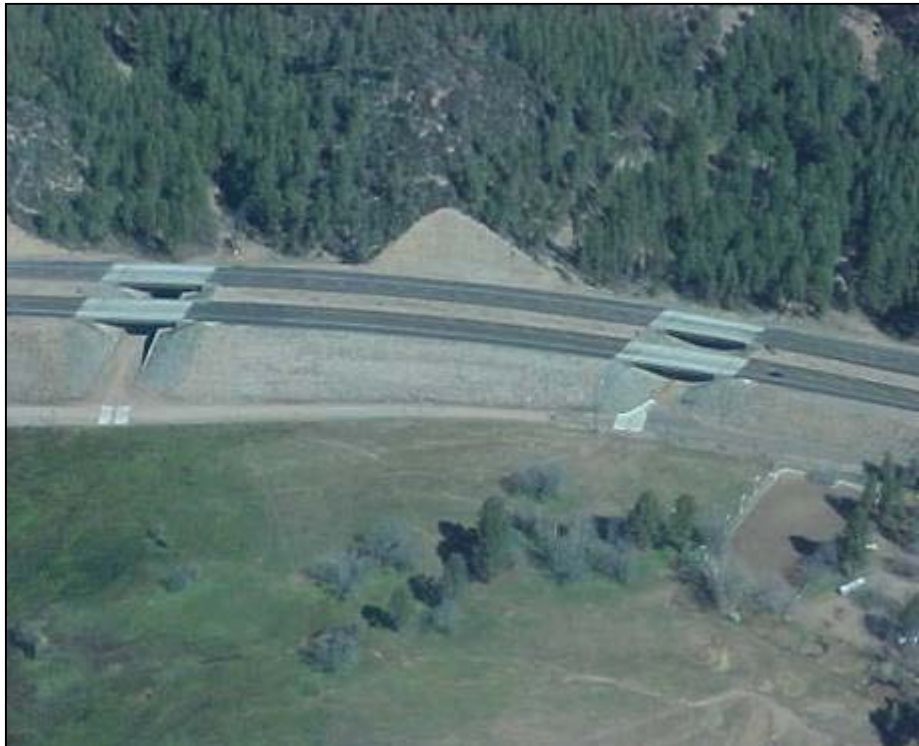
Figure 3.3. Aerial photographs of the Preacher Canyon Bridge (top) and the west and east underpasses at Little Green Valley along the PC section.

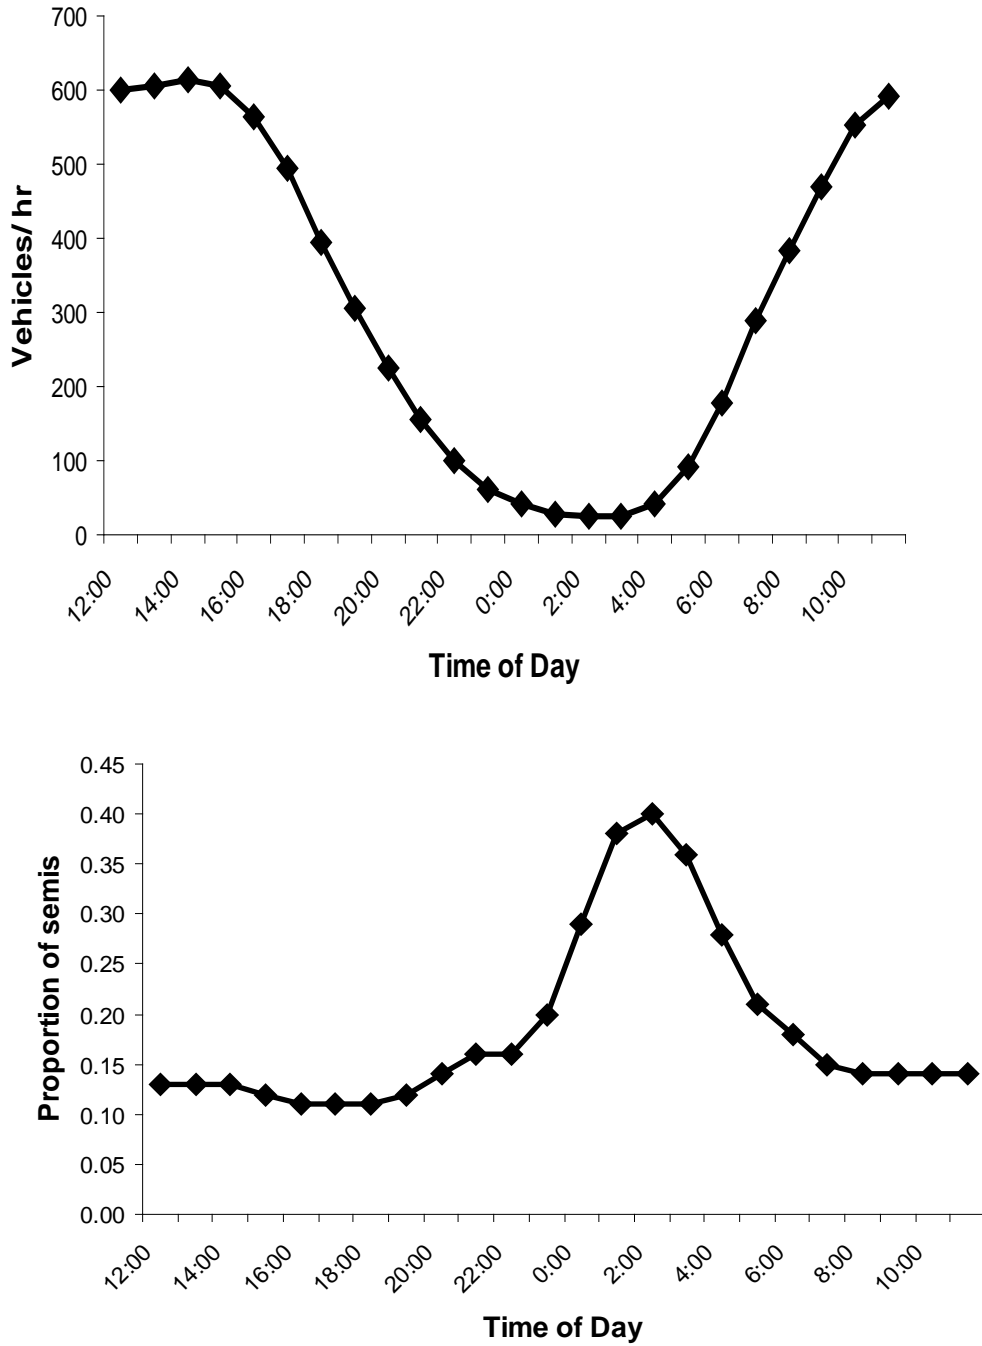
Figure 3.5. Mean hourly traffic volumes (top) and proportion of commercial vehicles to total vehicles (bottom) along SR 260 from 2004 to 2009.

Commercial vehicles travel SR 260 regularly, with a higher proportion during the times that passenger vehicle volumes are at their lowest (2400–0400; Figure 3.5). The proportion of commercial to passenger vehicles average as much as 0.40 from 0200–0300. Commercial

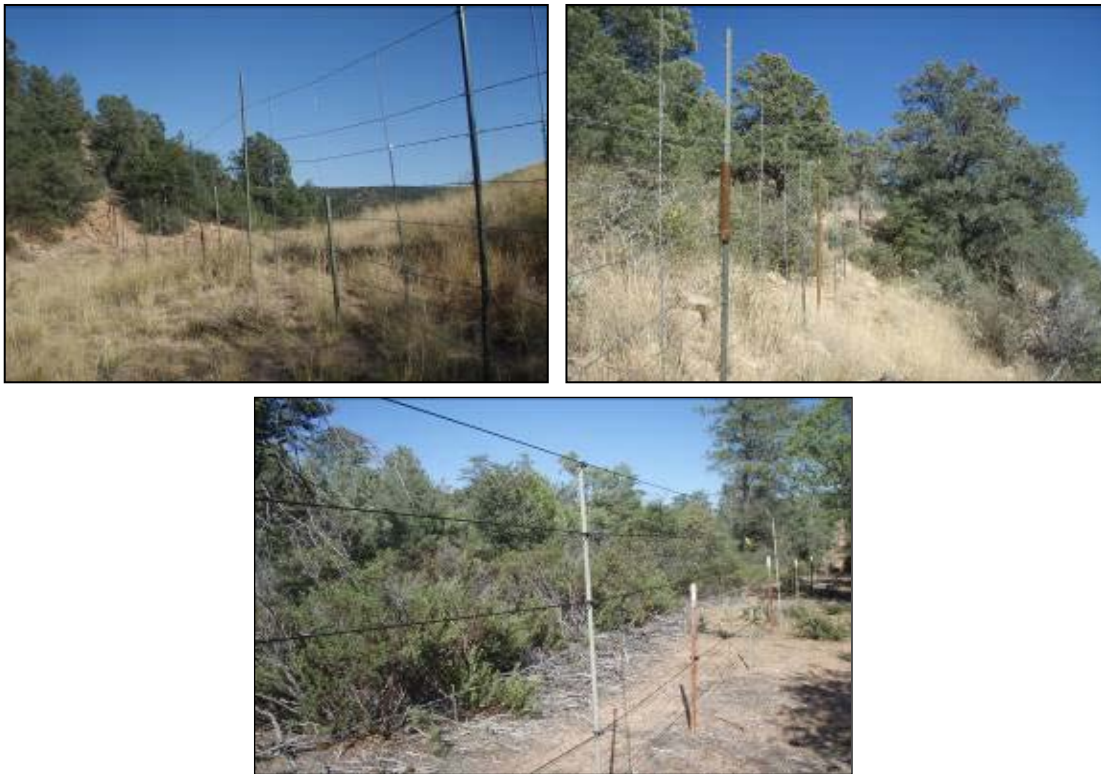
Figure 4.1. Types of retrofit fencing used to funnel animals to existing passage structures and the crosswalk along SR 260, including 10-ft T-posts and barbed-wire (top left), T-post sleeve extensions and barbed-wire (top right), and ElectroBraid™ electric fence modifications to extend the existing ROW fence to 7.5–8 ft.

Our research evaluated the efficacy of three retrofit fencing designs to guide animals to the underpasses and the crosswalk: 1) existing ROW fence raised to 8 ft high with 10-ft T-posts and barbed-wire, 2) existing ROW fence raised to 7.5 ft high with T-post sleeve extensions and barbed-wire, and 3) existing ROW fence raised to 7.5 ft high with ElectroBraid™ braided rope electric fence (Seamens and VerCauteren 2006) affixed to fiberglass poles and with a “kicker” attached to the ROW fence T-posts (Figure 4.1). These cost-effective (compared to ADOT’s standard woven wire ungulate-proof fence) retrofit fencing designs were integrated into the existing ROW fence for possible future modification or removal and to evaluate their effectiveness on other highways where reconstruction and installation of new ungulate-proof fence is not planned.

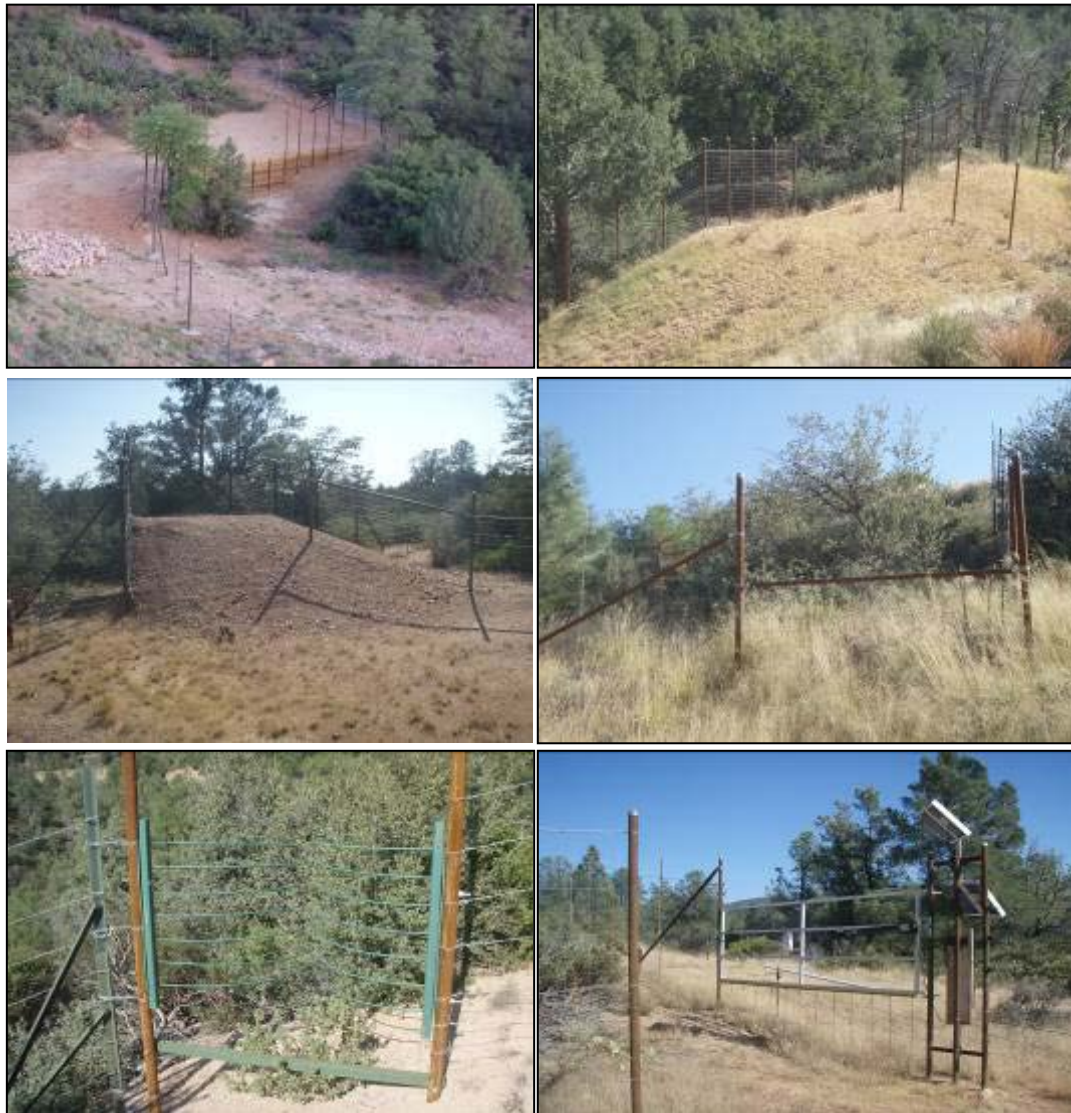
Figure 4.2. Right-of-way wildlife escape mechanisms incorporated into the project in the event elk entered the ungulate-proof fenced right-of-way along the Preacher Canyon section, State Route 260, Arizona. These mechanisms include three engineered escape ramps (top two and middle left photos), “slope jumps” installed in corners of the fencing (middle right photo), one-way gates (bottom left photo) and a pair of animal-activated electric gates (bottom right).

In the event that animals breached the fenced corridor and became trapped within the ROW, measures to allow them to escape were installed. These mechanisms include: 1) escape ramps, 2) “slope jumps” in the fencing, 3) one-way gates (Reed et al. 1974), and 4) a pair of experimental animal-activated self-opening electronic gates. The electronic gates were opened with a break-beam photo sensor situated along the fence far enough in advance of the gate so animals did not see movement of the gates as they opened; the gates closed automatically after two minutes (Figure 4.2).

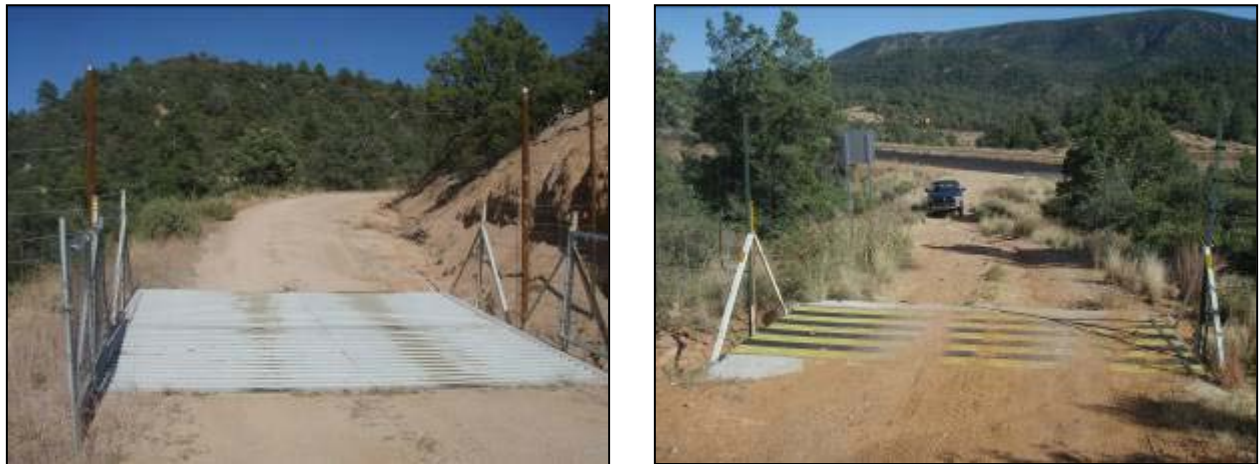
Figure 4.3. Dual cattle guard (left) and ElectroBraid™ ElectroMat (right) designed to allow lateral road access for vehicles while preventing wildlife from entering the fenced SR 260 ROW.

Two lateral side roads intersected the fenced highway corridor. To alleviate the potential ramifications of gates being left open and allowing animals into the fenced corridor, two systems were evaluated: 1) a dual cattle guard wide enough to prevent elk from jumping across, and 2) an electrified ElectroBraid™ ElectroMat, an alternative to a cattle guard (Figure 4.3).

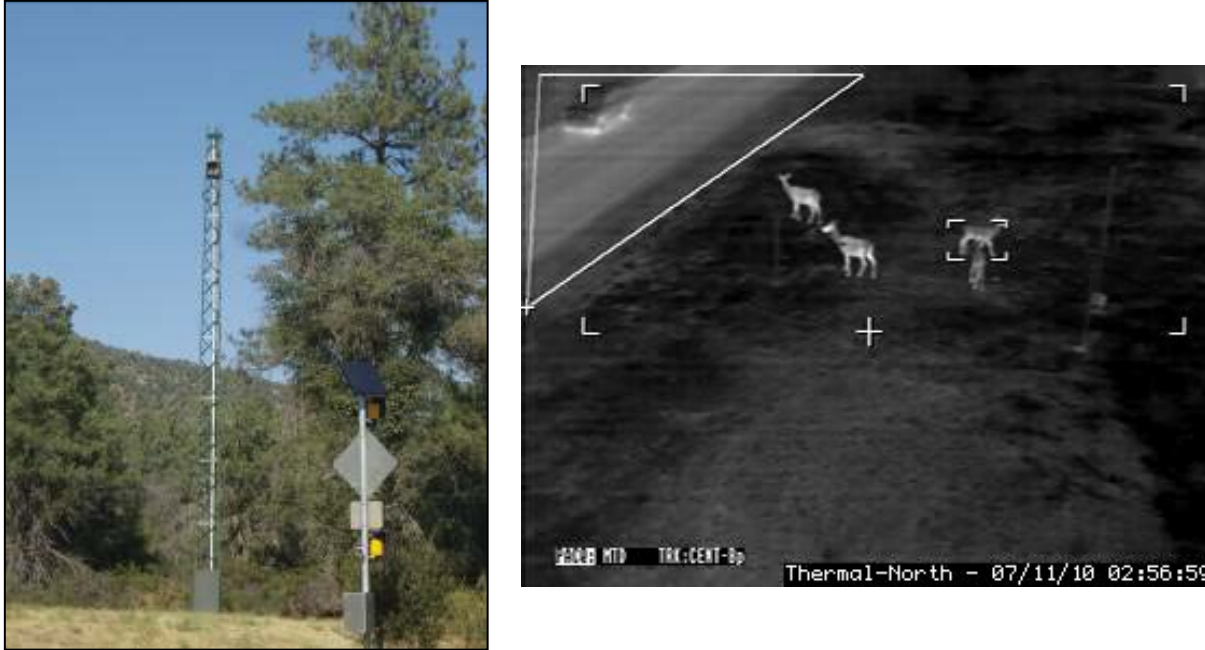
Figure 4.4. Tower-mounted infrared detection camera (left) and images of elk captured on target acquisition software (right).

At the western terminus of the extended ROW fence, ADOT contracted with ElectroBraid Fence, Inc. to design and implement a RADS-integrated “crosswalk.” This system was intended to alert motorists to wildlife entering the RADS detection zones. The crosswalk consisted of an infrared camera detection system integrated with military-grade target acquisition software to detect wildlife movement (Figure 4.4). This software was sensitive to both movement and size of the moving object such that small animals (e.g., rabbits) would not trigger the signs. Once an animal was detected, radio signals were relayed to activate signs alerting approaching motorists of the presence of animals within the crossing area (Figure 4.5). The RADS was configured such that a defined wildlife “crosswalk” was created with fencing (Figure 4.6). An adjacent undivided 2-lane section of the highway was selected to minimize the complexity of the detection system and the potential for animals to enter the highway ROW when they used the crosswalk. Motorists were presented with a series of signs: 1) a static sign reading “Test Area-Elk Crossing – 1500 ft ahead, 2) a variable message board that was activated by the RADS when wildlife were present displaying “Caution – Elk – Detected,” and 3) a RADS-activated warning sign at the crosswalk with flashers that displayed the silhouette of an elk (Figures 4.5 and 4.6). The system was operational 24 hrs a day.

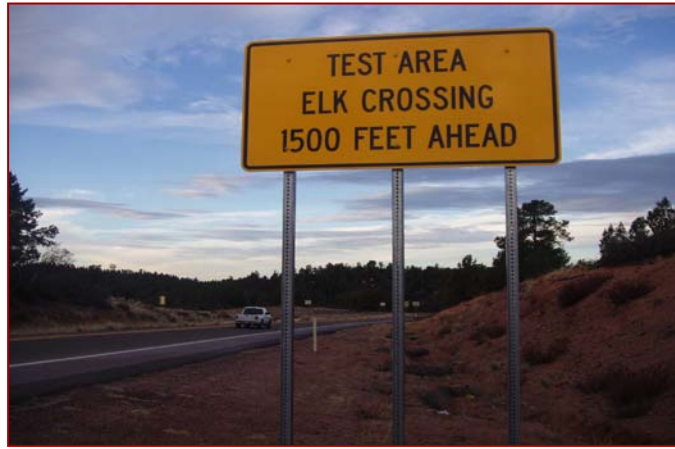
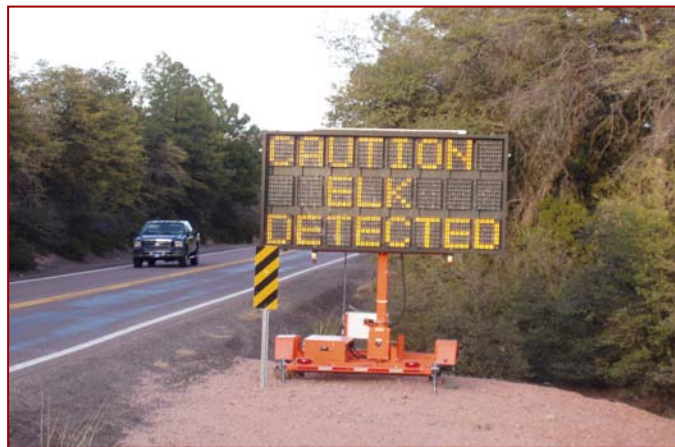
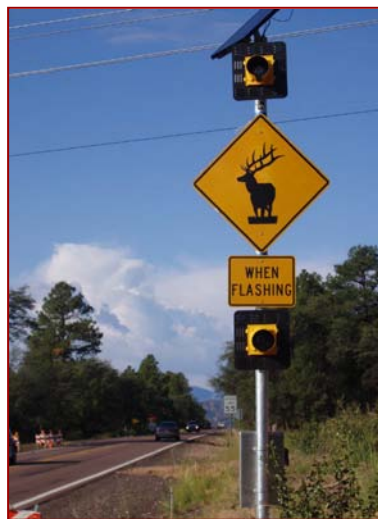
Figure 4.5. Array of signs presented to motorists as they approach the SR 260 wildlife crosswalk. A static sign (top) alerts motorists that the detection area lies ahead, while the variable message board (middle) and the flashing lights on the elk silhouette sign (bottom) are only activated when animals were detected by the RADS.

Because RADS was new technology to Arizona, the research team evaluated the degree to which it remained operational as well as its ability to elicit a change in driver behavior (e.g., reducing motorist speed). This study therefore integrated and evaluated the efficacy of several new technologies, including different fence designs and mechanisms to maintain the integrity of the fenced corridor, as well as assessing the utility of the RADS and crosswalk as a potential alternative to costly wildlife passage structures. The crosswalk is a hybrid of RADS, similar to those evaluated by Gordon et al. (2004) and Huijser et al. (2006b) combined with a defined crossing area as evaluated by Lehnert and Bissonette (1997). Also similar to the crosswalks described by Lehnert and Bissonette (1997), an unfenced gap existed between the shoulder of the roadway and the end of fencing. This gap provided access for wildlife to move within the fenced ROW, risking WVC until they returned via the same gap or left through an escape mechanism. Lehnert and Bissonette (1997) documented entry through similar gaps even with obstructive cobble fields laid in the gaps and painted lines, simulating cattle guards.

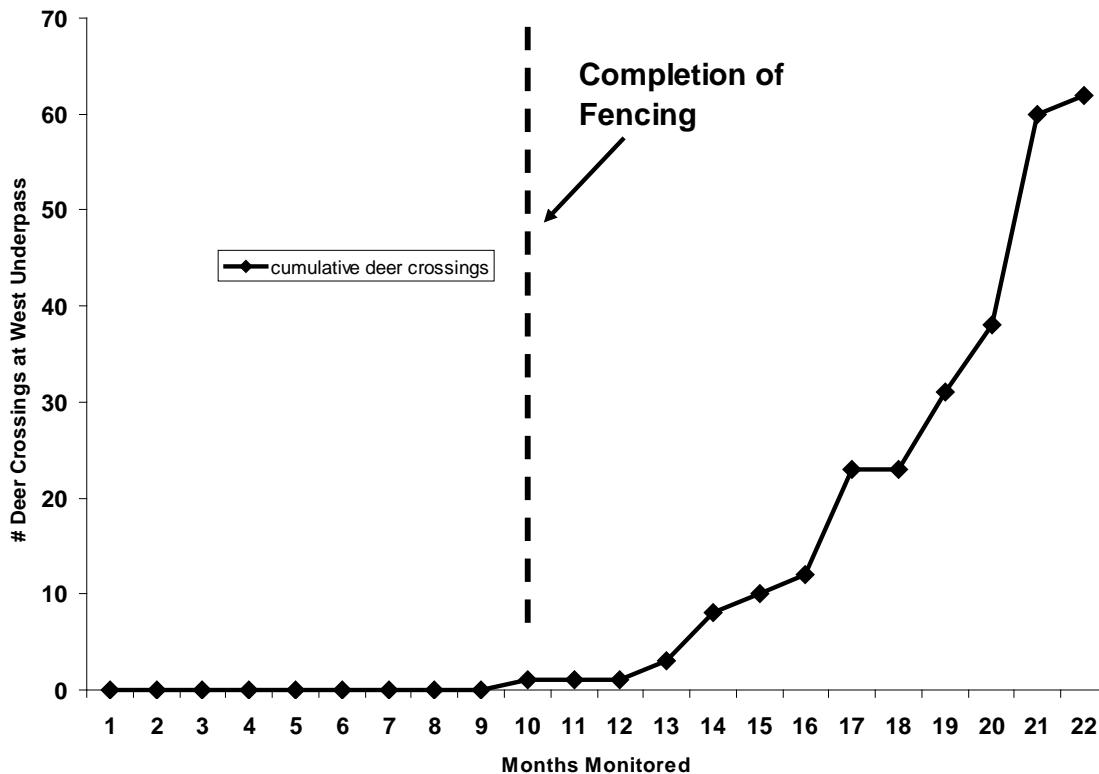
Figure 8.3. The number of white-tailed deer crossing the highway below-grade through the west Little Green Valley underpass before and after the modification of fencing in early 2007.

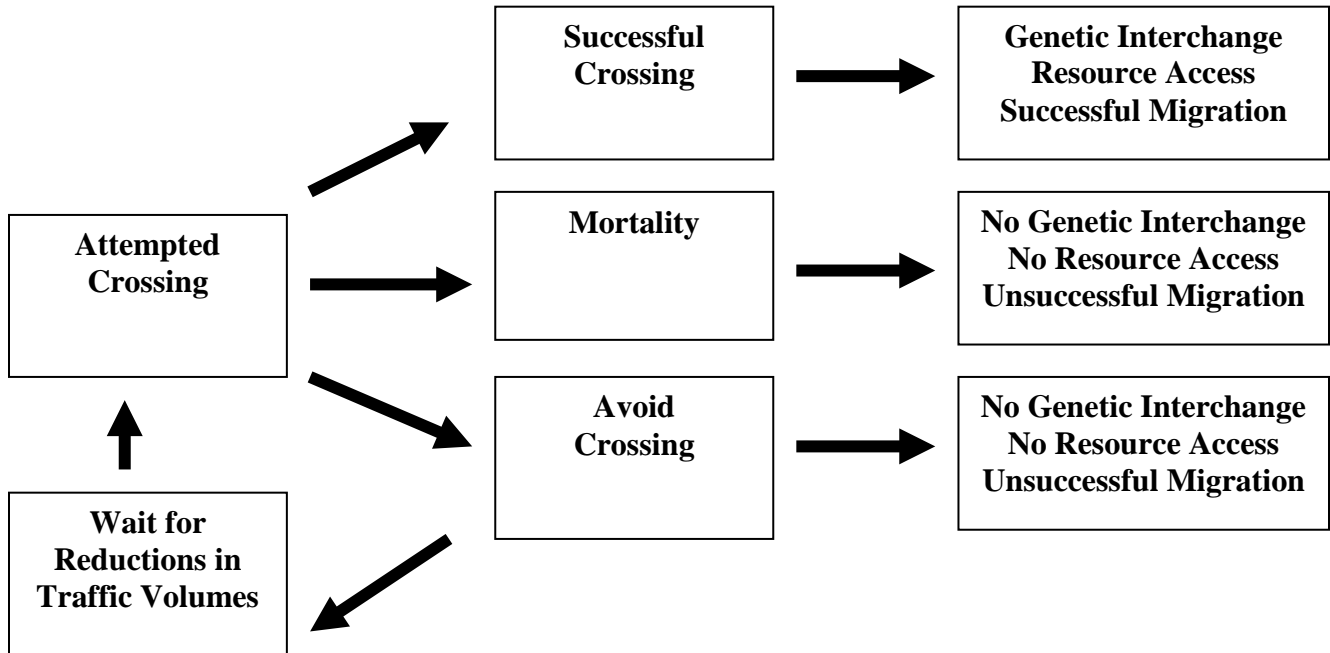
Figure 10.1. Model depicting outcomes for at-grade highway crossing attempts of large ungulates at high traffic volumes.

probability of an animal successfully crossing the road at-grade. When animals attempt highway crossings at high traffic volumes, three outcomes can occur: 1) a successful crossing, 2) mortality by collisions with vehicles, or 3) avoid crossing altogether or attempt to cross again when traffic volumes reach lower levels (Gagnon 2006; Figure 10.1). The success of many large ungulates in crossing highways at-grade is often predicated on traffic volume. As volumes increase the probability of successfully moving through a “gap” in the traffic is reduced and the potential for mortality is increased (Langevelde and Jaarsma 2004, Waller et al. 2006).
